Safety Information Letter concerning sailplane storing conditions and corrosion of flight control systems

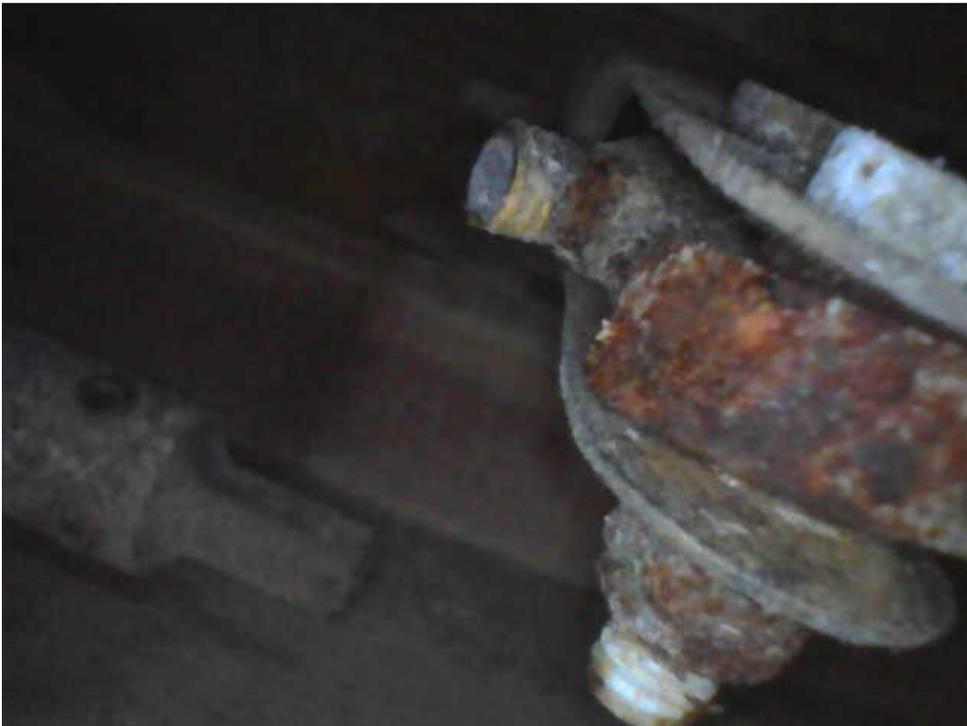
There has been reported occurrence of corrosion on flight control pushrods and rod ends inside the wings of PIK-20 D sailplanes stored in unventilated trailers. In one occasion this has led to pushrod rod end fracture. As the loading during flight in normal operation is very low, a possible cause is that the rod end bearing has seized due to the corrosion causing bending loads in the rod end shank when actuating the flight controls. Rod end fracture could cause loss of control of the aircraft, if occurring in a single load path control line, such as the elevator control line.

Picture 1 Corroded and fractured push rod rod end inside a wing.

- 4.5. If significant corrosion is detected, rectify corroded parts by replacement or using approved methods and replace corroded rod ends especially when there is corrosion in the rod shank thread with serviceable ones before further flight.
