## Safety Information Letter concerning sailplane storing conditions and corrosion of flight control systems

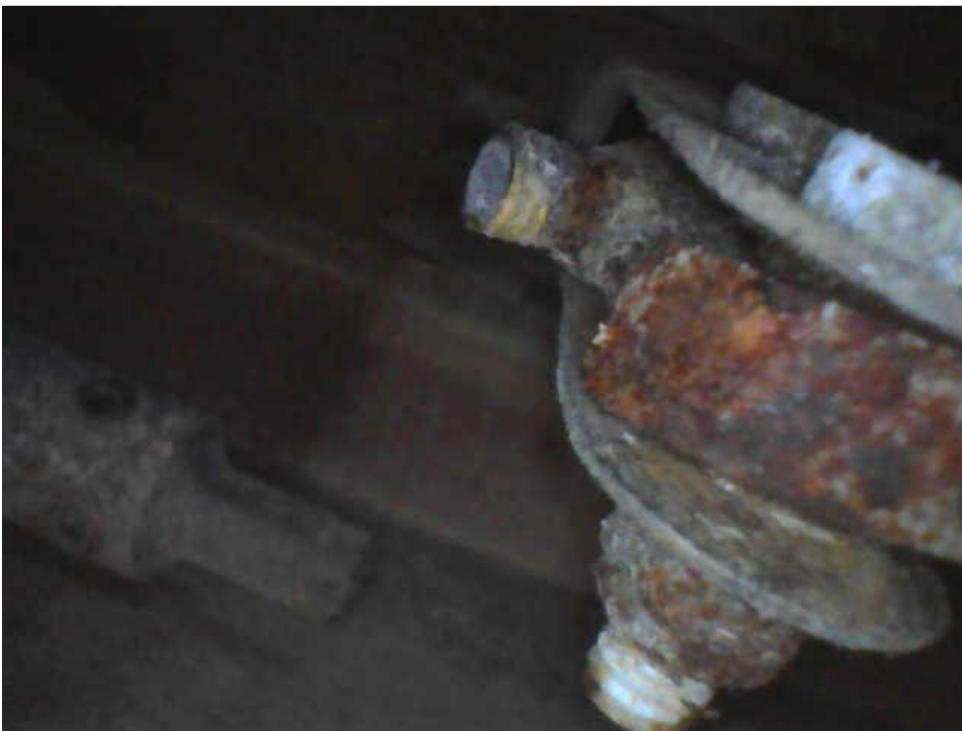
There has been reported occurrence of corrosion on flight control pushrods and rod ends inside the wings of PIK-20 D sailplanes stored in unventilated trailers. In one occasion this has led to pushrod rod end fracture. As the loading during flight in normal operation is very low, a possible cause is that the rod end bearing has seized due to the corrosion causing bending loads in the rod end shank when actuating the flight controls. Rod end fracture could cause loss of control of the aircraft, if occurring in a single load path control line, such as the elevator control line.

*Picture 1 Corroded and fractured push rod rod end inside a wing.*

- 4.5. If significant corrosion is detected, rectify corroded parts by replacement or using approved methods and replace corroded rod ends especially when there is corrosion in the rod shank thread with serviceable ones before further flight.
